## 20 KV OVERHEAD LINES WITH COVERED CONDUCTORS

W. Panosch<sup>1</sup>, K. Schöngrundner<sup>2</sup>, K. Kominek<sup>3</sup>

EVN AG, Austria

The experiences of an Austrian utility, an overhead-line fittings producer and a conductor company are reported in this paper.

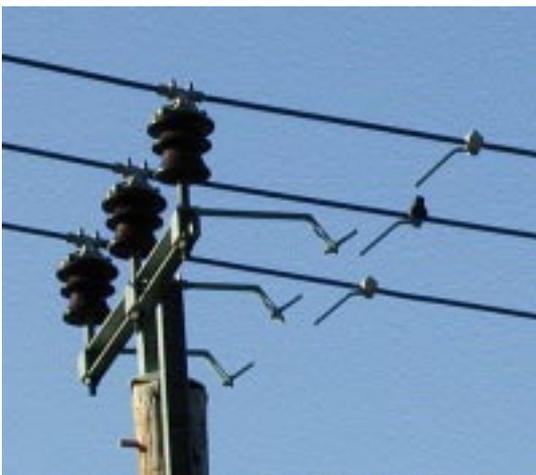
**Picture 3.** Suspension pole with oscillating clamps and lightning protection.

Arcing horn on each 4<sup>th</sup> pole. At the existing tranformer stations surge arresters are used.

Suspension pole: Oscillating groove clamps and side ties. The sheath of the conductor is not removed at the clamps.

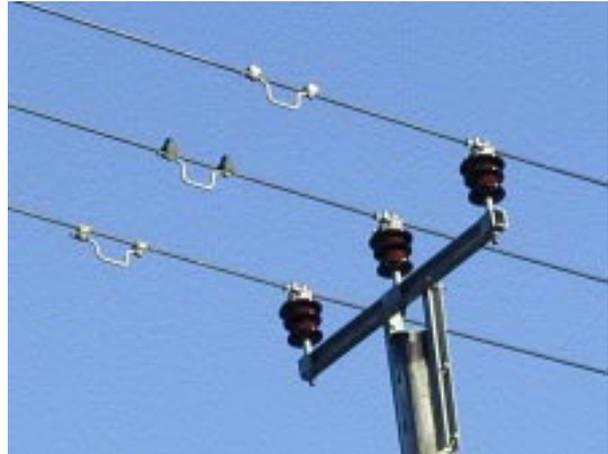
**Picture 4.** suspension pole with earthing stirrups.

Earthing stirrup on each 3<sup>rd</sup> suspension pole or angle pole (pict. 4). At the tension pole the earthing

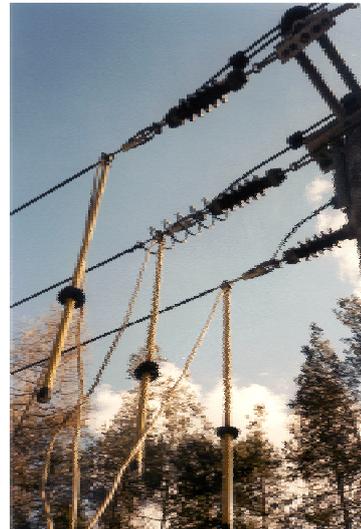
**Picture 5.**

point is the area of removed conductor area near to the wedgeclamp (pict. 5).

Tension pole with bird protection (helicoil fitting) and connected earthing equipment.

Bird protection spiral fittings: They are made of black carbon polyamid, outer diameter 18 cm. They are mounted at the middle phase conductor upon the metallic

wedge clamps, they prevent contact by birds. (danger of a short circuit due to contact by the wings of the birds).

Tension pole: Double wedge clamps on bare conductor (insulation removed).

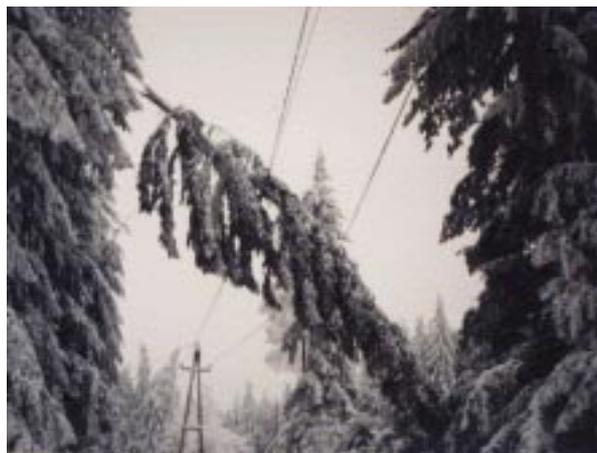
**Picture 9:** Safe supply during extreme weather situations in winter 95/96 in the area of EVN.

- No faults or troubles with snow or hoarfrost.
- No interruptions by dropping branches
- Branches or trees were moved away under normal working conditions.
- No faults with touching conductors by ice-shedding.
- No additional costs after changing the conductors.
